WATER POLLUTION SURVEY

TOWNSHIP OF LONGLAC

DISTRICT OF THUNDER BAY

1967

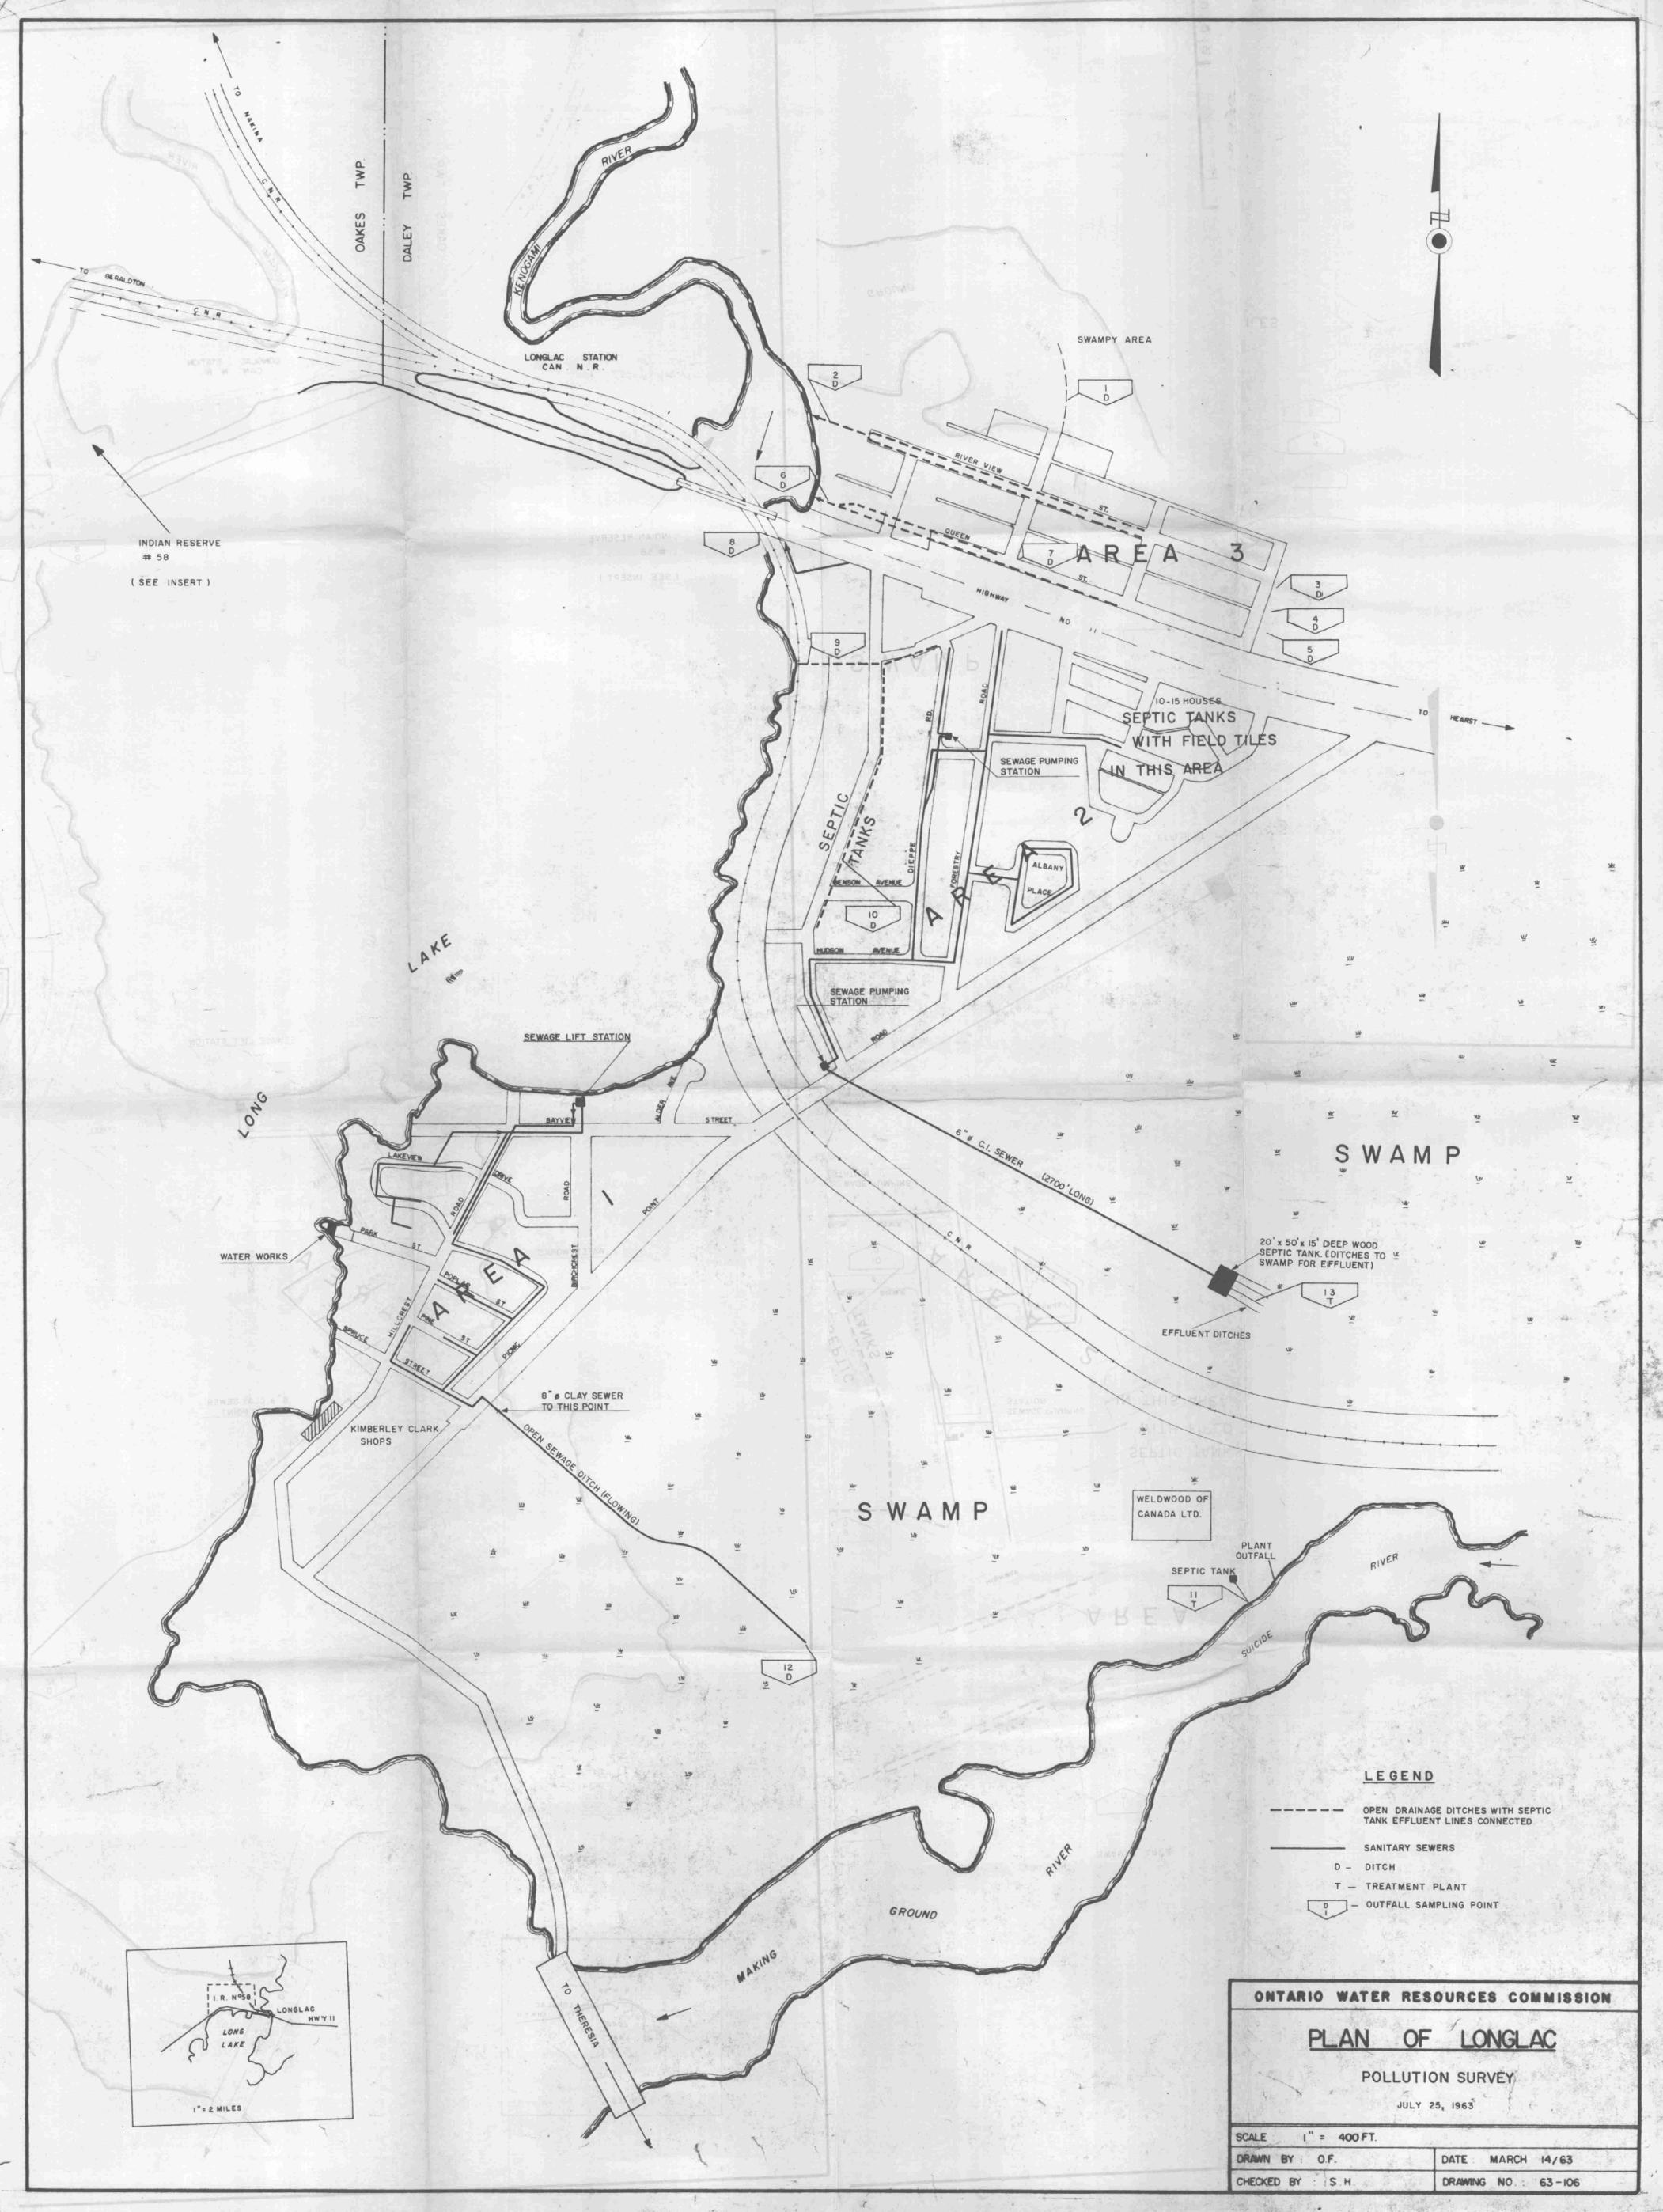
Two sections of the Town, designated on the accompanying plan as area No.1 and part of area No.2 are partly serviced by mun-icipal water works and sanitary sewers.

The No.3 area, as indicated on the map, is situated north of No.11 Highway. No municipal sewage collection services, and only a few water services are provided in this area. Individual septic tank systems are reportedly in use for sewage treatment, and shallow dug private wells provide the water supplies.

The locations of sampling points are indicated on the accompanying map.

All surface water drains examined in the section of Longlac North of Highway No.11 contained visible evidence of untreated wastes and sewage. Attention is drawn to the extreme conditions of pollution as indicated by the analyses of samples collected from drains at the east end of Riverview and Queen Streets, and at points along Forestry Road extention. (Sample Points No.1,2,3,4,5,6,7)
